Property Inventory and Condition Survey
for the
Group IV Utility Systems Property

and
Group II Chemical Plant Property
within the

Shell Oil Company Leasehold Area
at
US Army Rocky Mountain Arsenal
Commerce City, CO.

VOLUME THREE

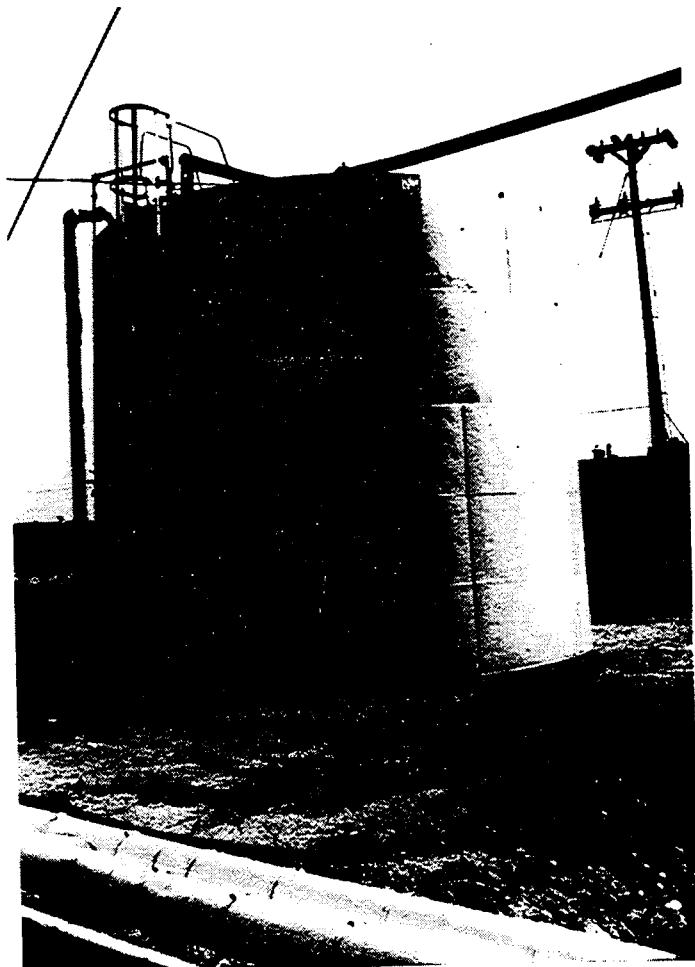
BUILDING NO. 321A (TANK): General View

Exterior. (Looking East)

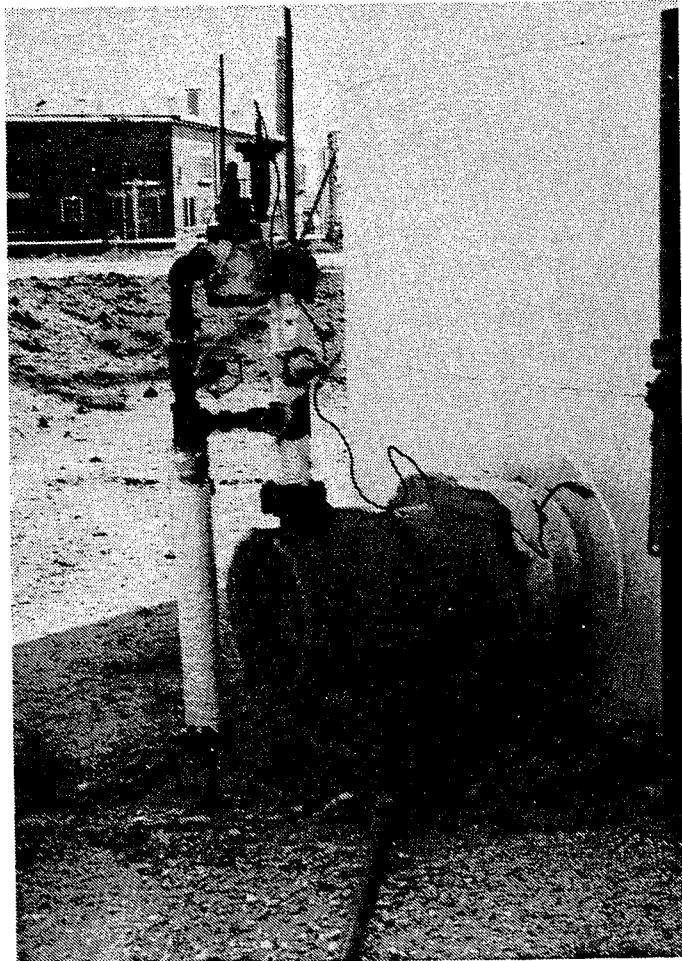
Structure is a welded steel tank, 24'-6" in diameter x 20'-6" high. Capacity 72,000 gallons. The tank has an earth foundation, is equipped with a safety ladder, a flame arrestor, an automatic tank gauge and steam coils, all in good (G) condition.

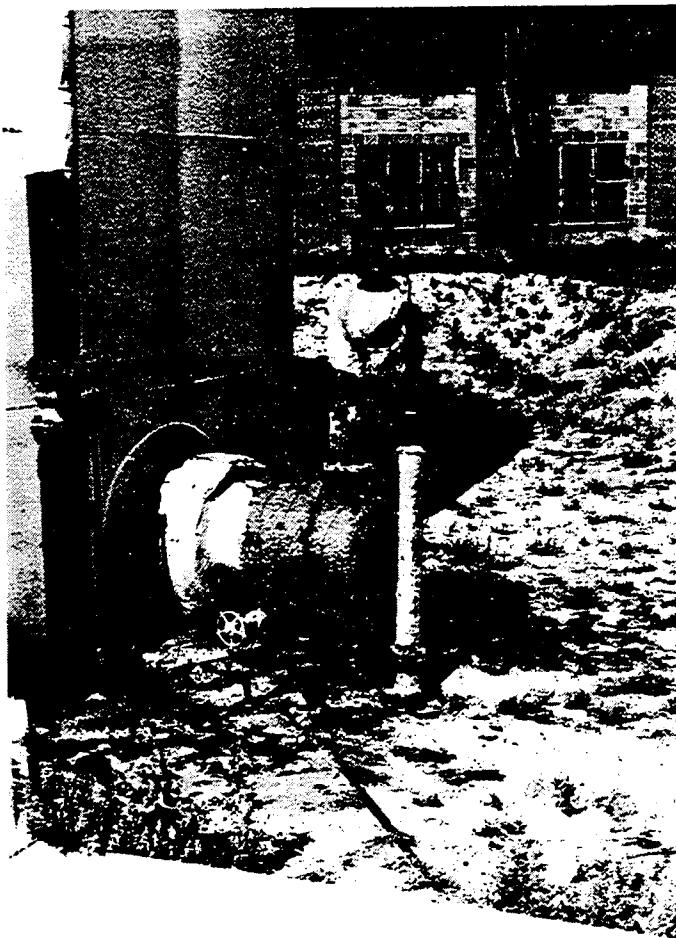
Structure is a welded steel tank 23' in diameter x 20'-6" high. Capacity 60,000 gallons. The tank has an earth foundation, is equipped with a safety ladder, a flame arrestor, an automatic tank gauge and steam coils, all in good (G) condition.

BUILDING NO. 321B (TANK): General

View Exterior. (Looking Northwest)

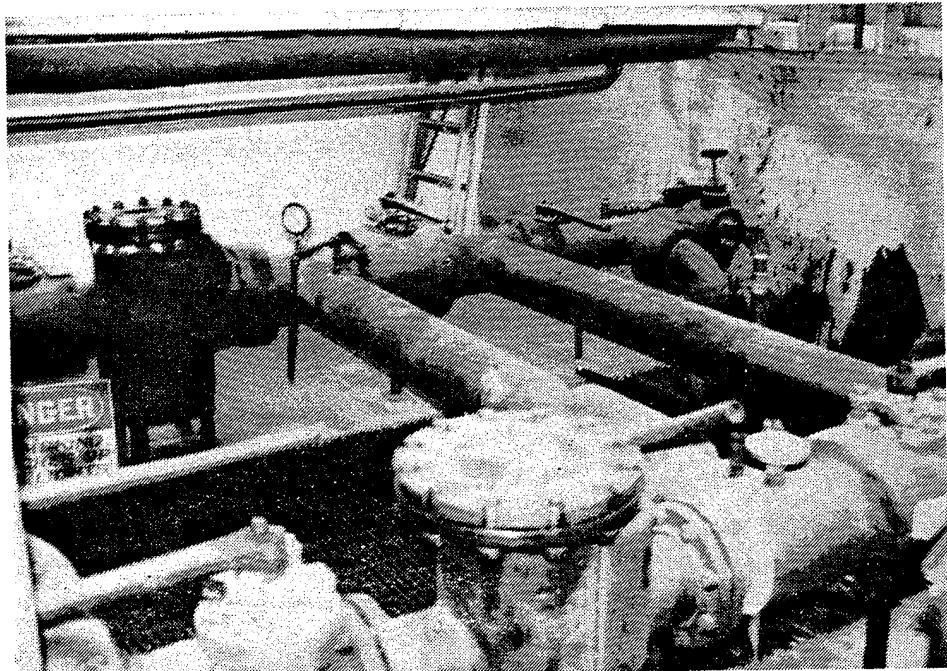
BUILDING NO. 321C: Interior. Pumps
and Motors
Date of Photograph: 30 August 1982

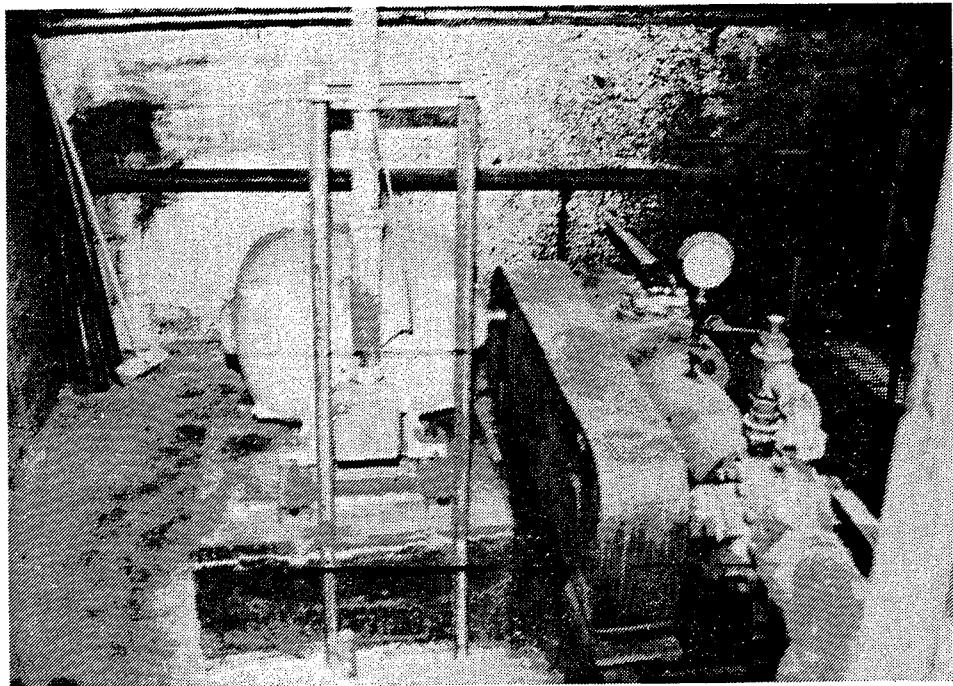
BUILDING NO. 321C: Interior.
Date of Photograph: 30 August 1982

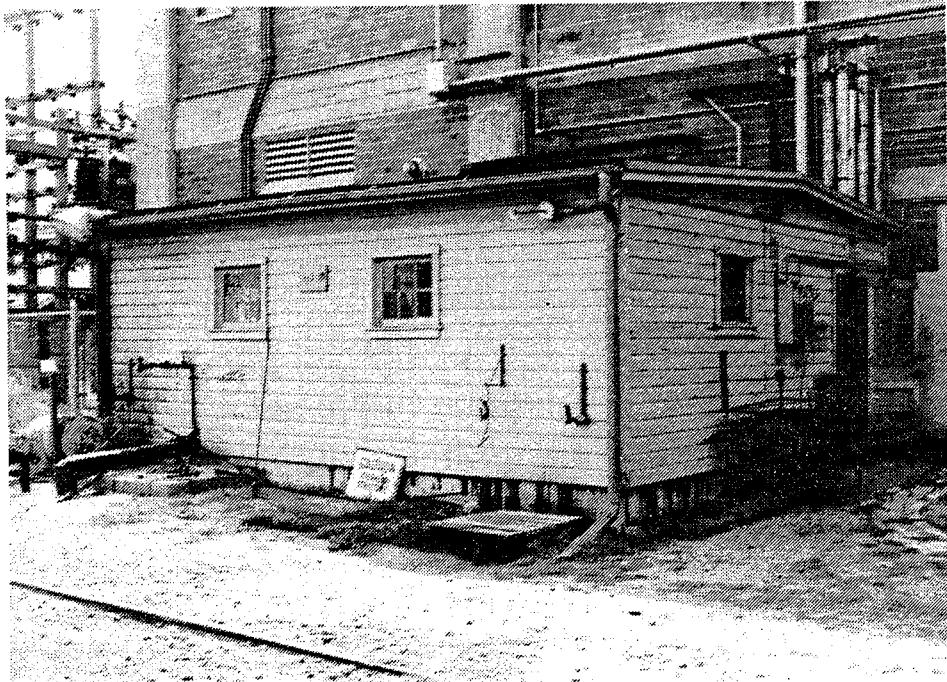
Building is 23' x 24'-6" x 8' high, with concrete floor and foundation, wood frame construction, wood walls and roll roofing over wood sheathing. Two fire extinguishers are provided. The general condition of the building is fair (F).

BUILDING NO. 321D: General View Exterior.
(Looking West)
Date of Photograph: 1 September 1982

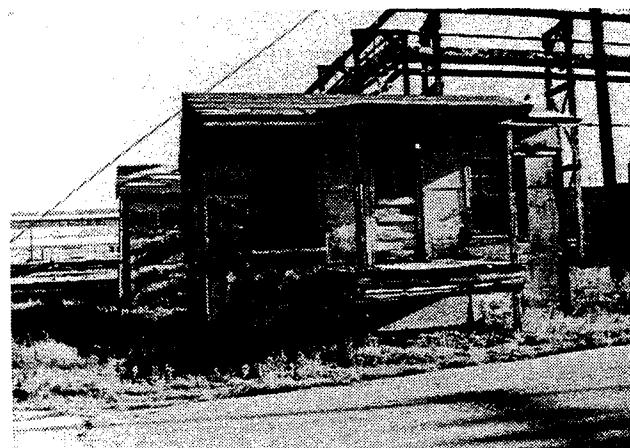
BUILDING NO. 321E: Pump
Date of Photograph: 30 August 1982

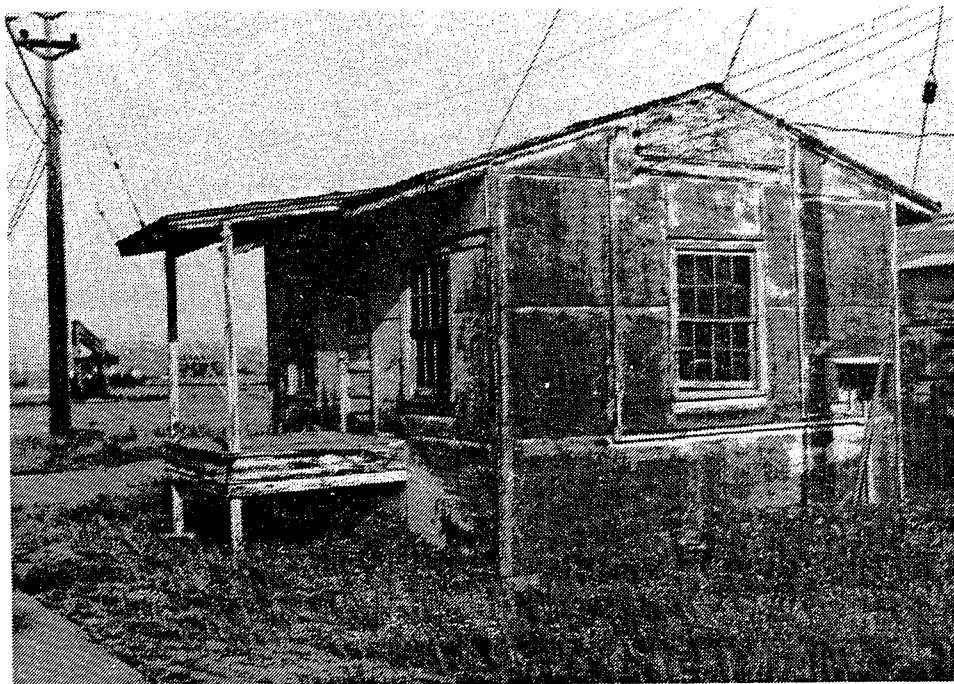
3.00 PRESENT CONDITION. Building No. 322 is in generally fair (F) condition. The estimated remaining useful life of this building from August 1982, with minimum maintenance and no building use change, is 8 years.

BUILDING NO. 322: General View Exterior.
(Looking East)
Date of Photograph: 31 August 1982

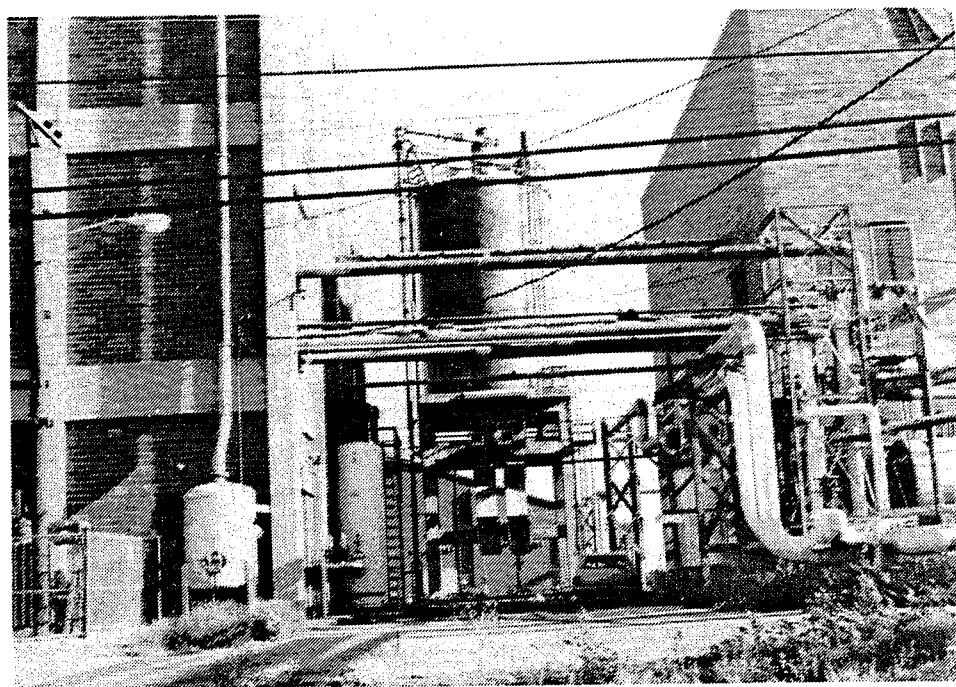
3.00 PRESENT CONDITION. The hopper structure is in good condition (G), but is probably not operational without major work on the equipment. The estimated useful life of the structure as of August 1982, with minimum maintenance and no building use change, is 25 years. (Structure has not been used in many years.)

BUILDING NO. 323: Ash Handling
Hopper. General View.
Date of Photograph: 31 August 1982

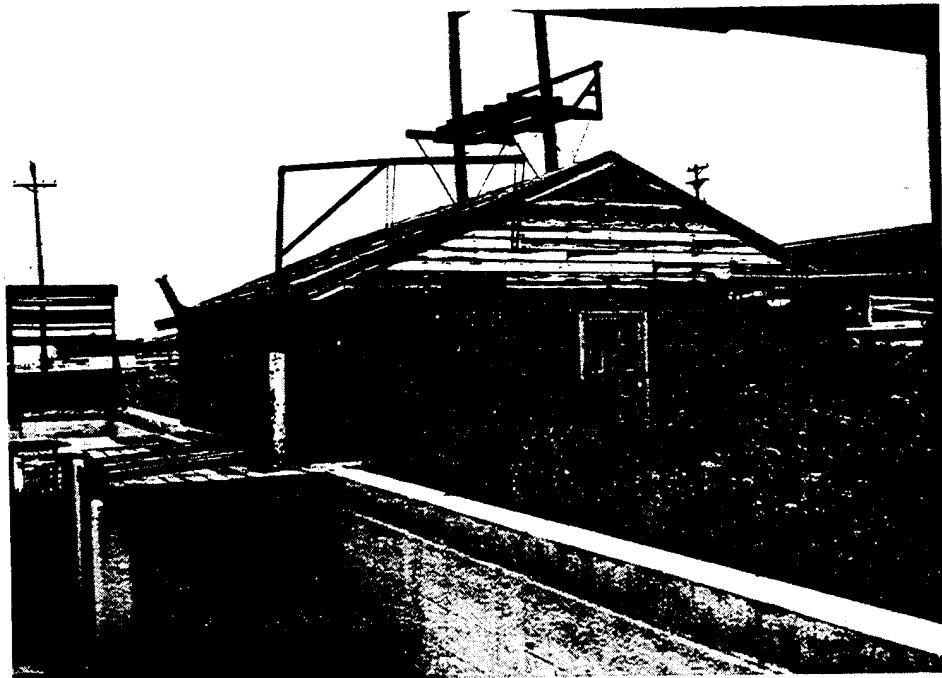
BUILDING NO. 326: General View of
North and West Elevation
Date of Photograph: 27 August 1982

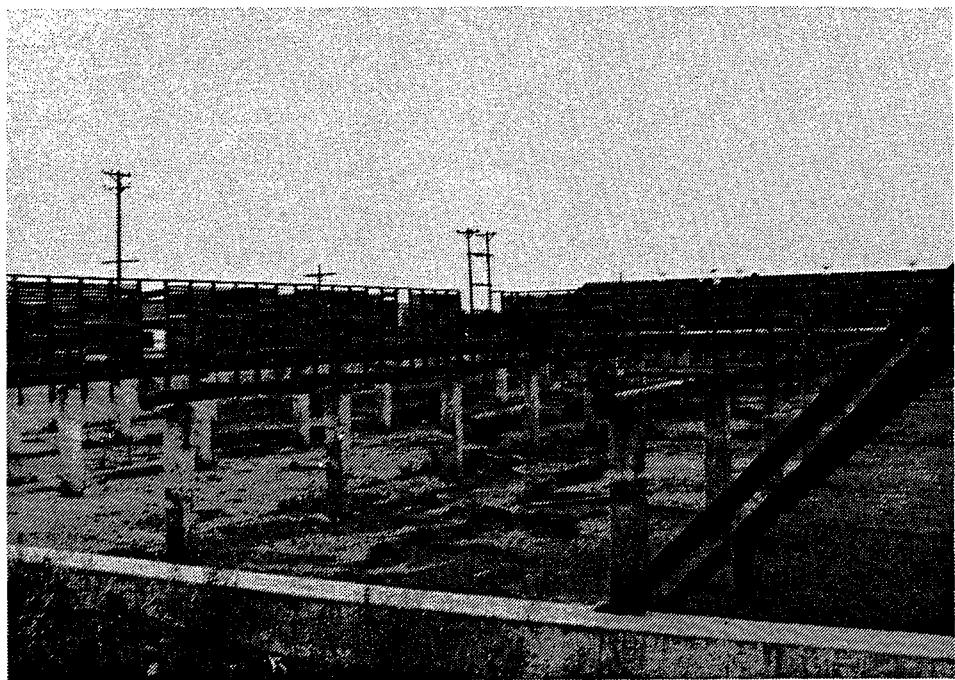
3.00 PRESENT CONDITION. The spray pond louvers are in poor (P) condition and the concrete floor is badly cracked. The piping is in poor condition and has been disconnected (P). The pump house is in fair (F) condition. The estimated useful life of the building from August 1982, with minimum maintenance and no building use change is 10 years.

BUILDING NO. 326: General View.
Spray Pond
Date of Photograph: 27 August 1982

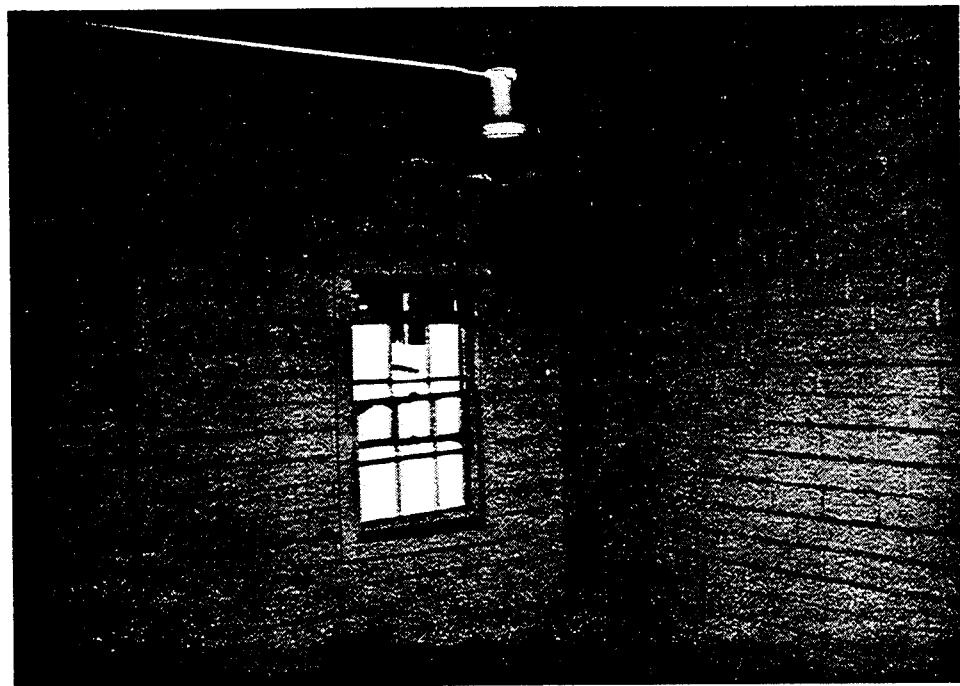
BUILDING NO. 337: Interior.
(Looking North)
Date of Photograph: 27 August 1982

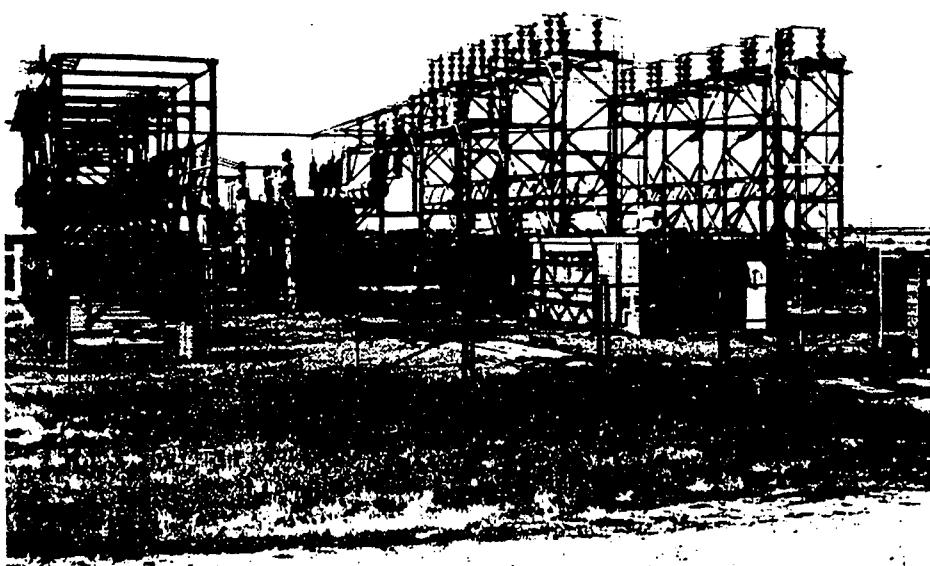
BUILDING NO. 361: Primary Substation (Looking East)

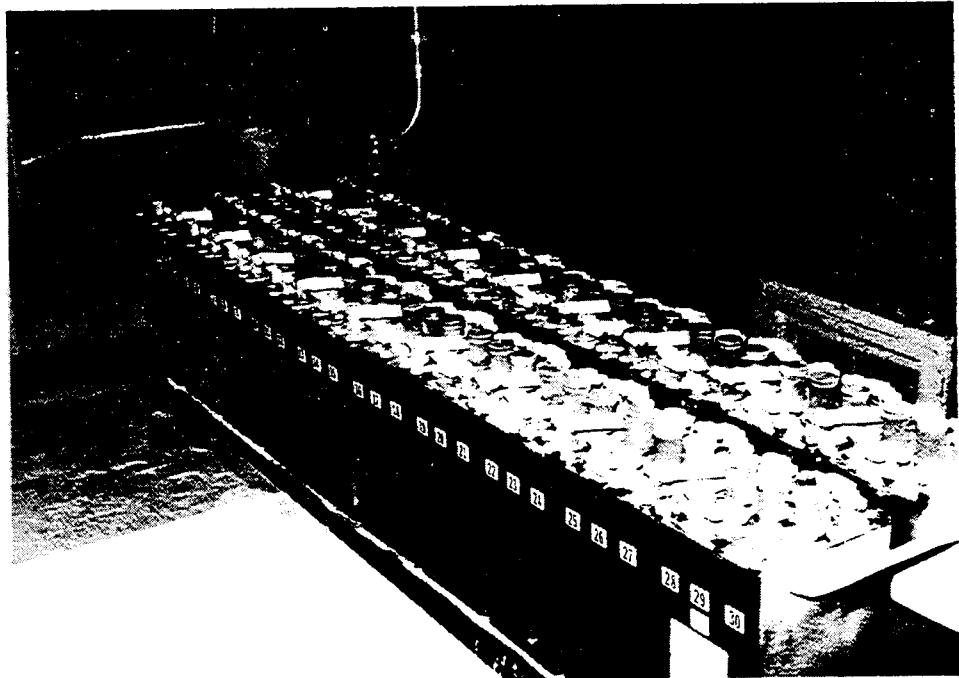
BUILDING NO. 361: Battery Charger
(Replacement)
Date of Photograph: 26 August 1982

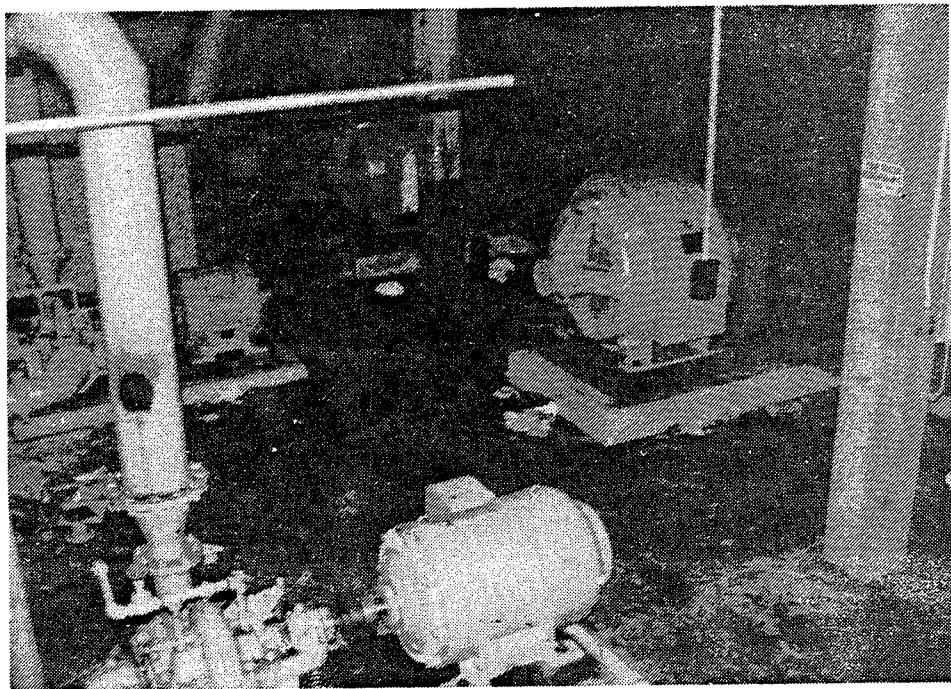
BUILDING NO. 371: Pump
Date of Photograph: 30 August 1982

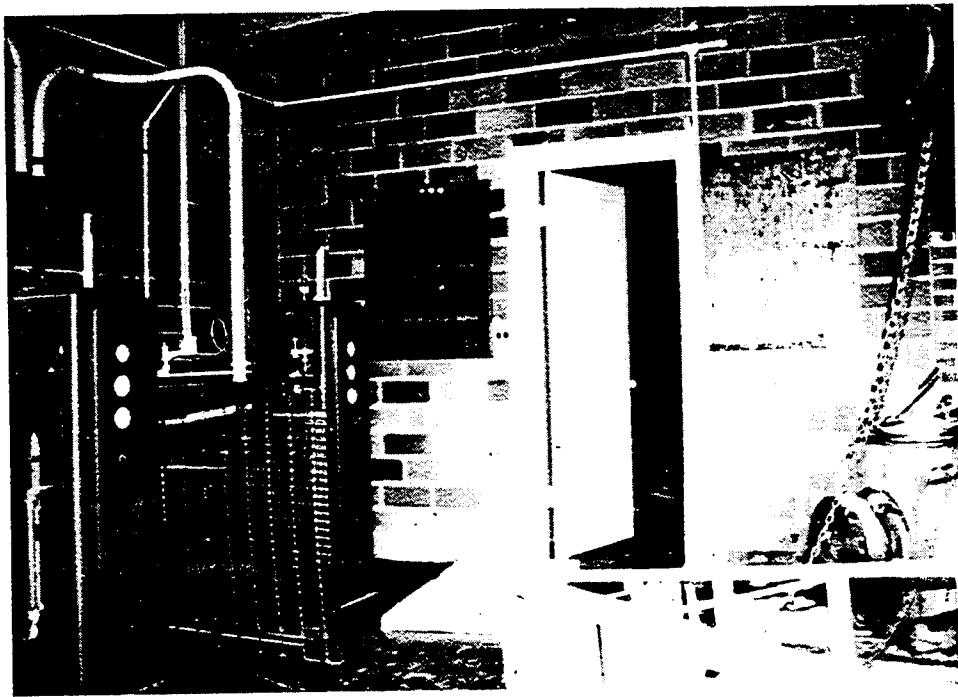
BUILDING NO. 371: Basement Pump
Room (Motors Removed for Repair)
Date of Photograph: 26 August 1982

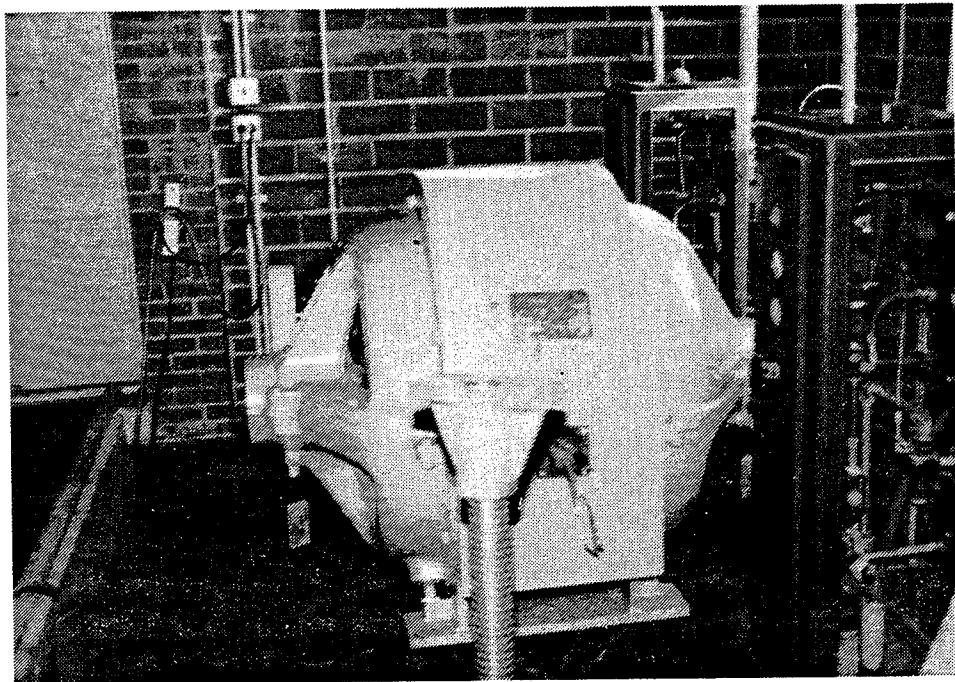
BUILDING NO. 371: Chlorination
Room (Looking South)
Date of Photograph: 26 August 1982

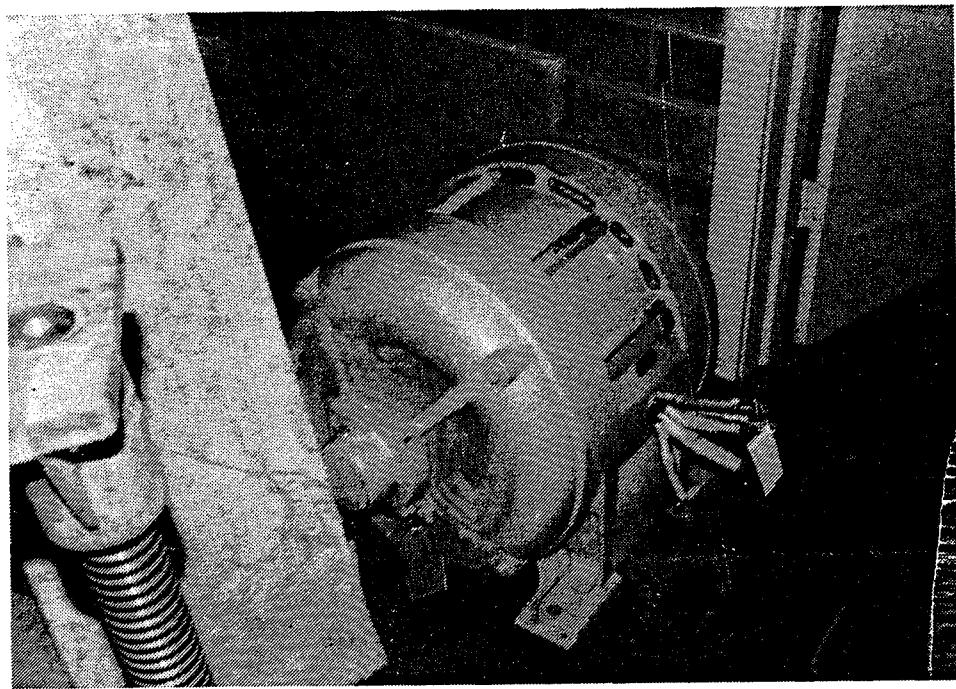
BUILDING NO. 371: Motor (Not
Installed Stored in Chlorination Room
Date of Photograph: 7 September 1982

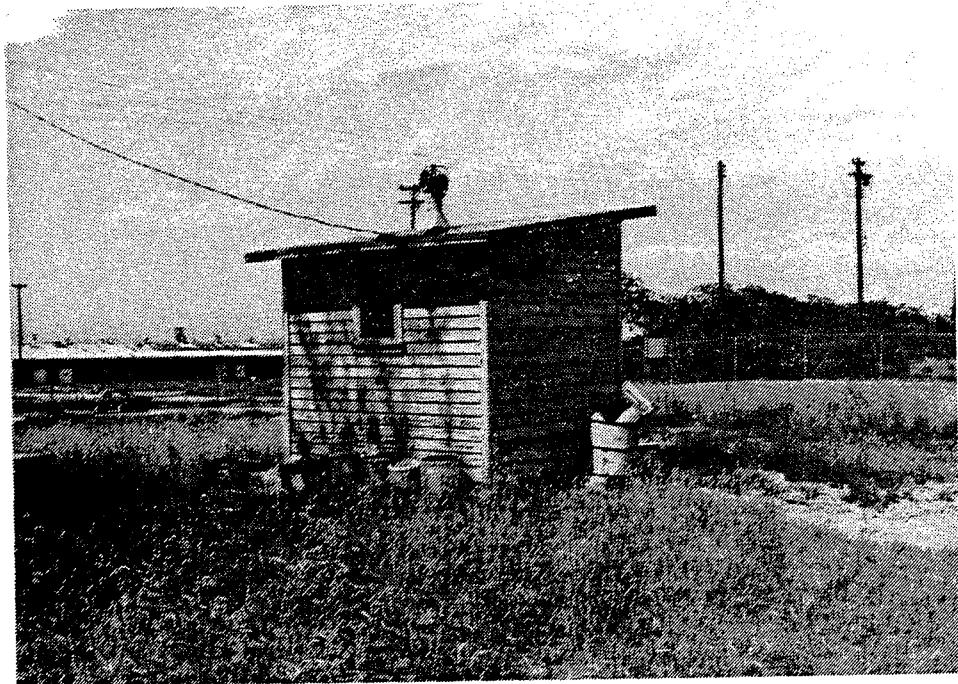
3.00 PRESENT CONDITION. The building is in fair (F) condition, but the equipment is badly corroded. The estimated remaining useful life of this building as of August 1982, with minimum maintenance and no building use change, is 10 years.

BUILDING NO. 378: Exterior
Date of Photograph: 26 August 1982

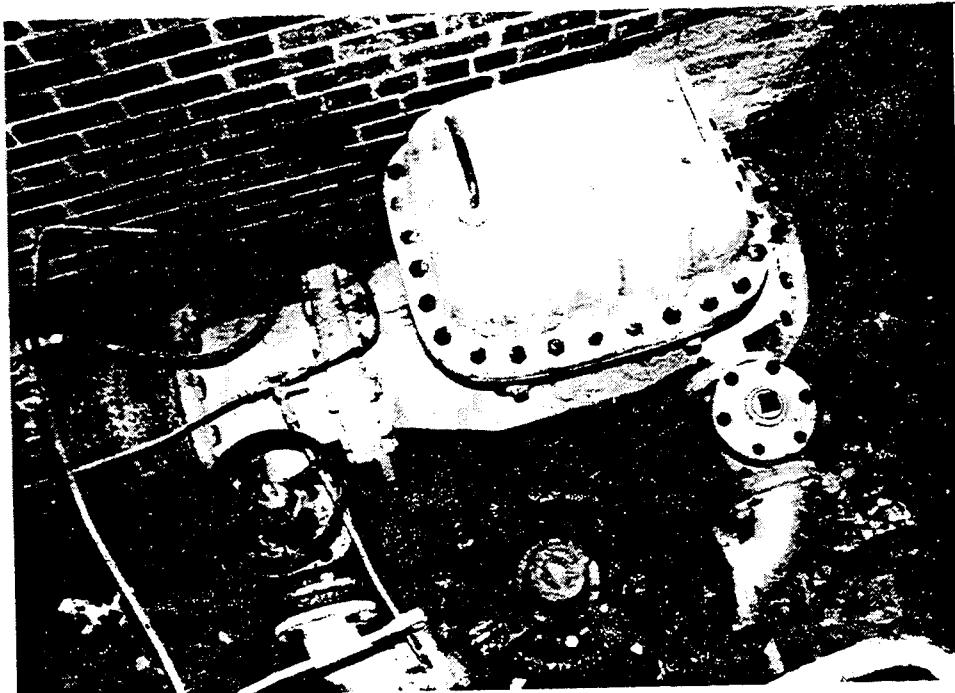
BUILDING NO. 378: Hersey Detector
Check Trio Meter
Date of Photograph: 26 August 1982

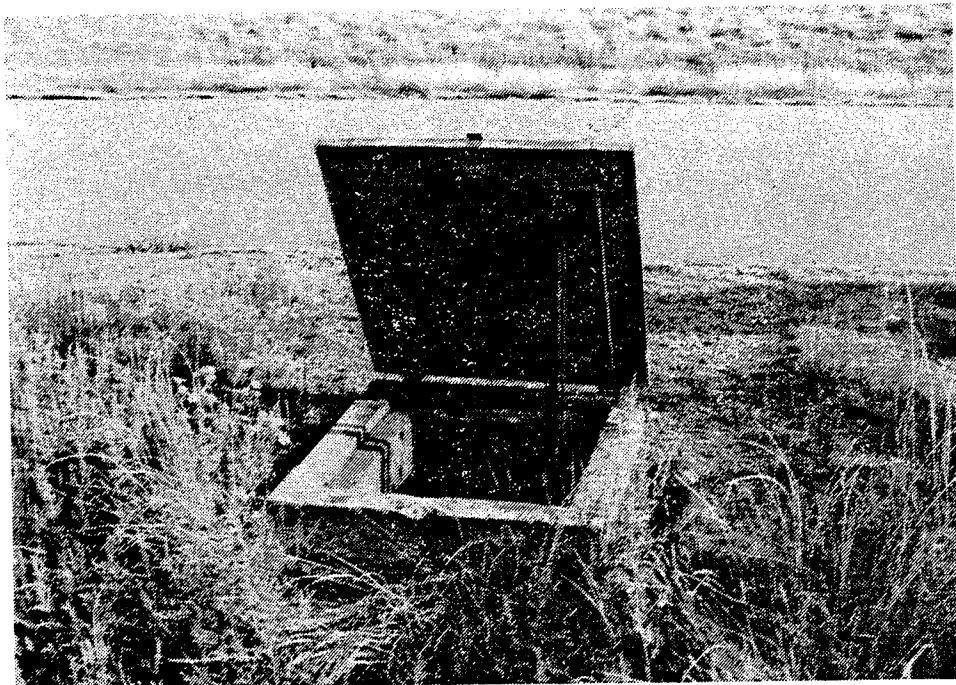
There is no foundation. The building has a gravel floor and concrete roof and brick walls. This is a standby chlorinator station and the piping is badly corroded on the exterior. Externally the meters appear in good condition (little corrosion), however, there is no way of determining if there is any internal corrosion. This facility is not currently operational; chlorinator pumps have been removed.

BUILDING NO. 382: Exterior
(Looking South)
Date of Photograph: 7 September 1982

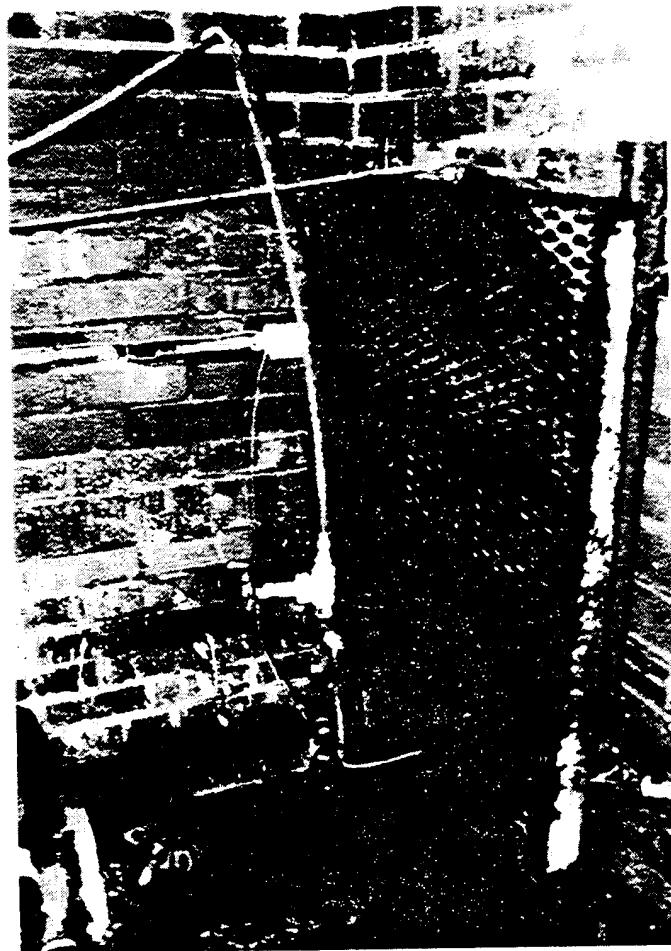
BUILDING NO. 382: Interior
Chlorine Injection Valves
Date of Photograph: 7 September 1982

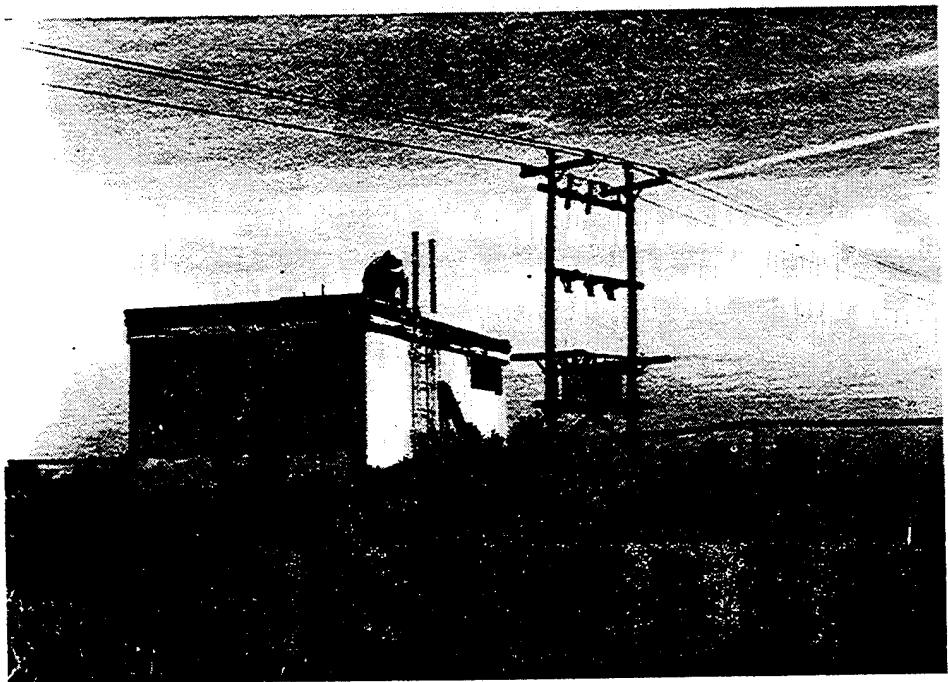
BUILDING NO. 385 (WELL NO. 1): General
View of Pump House. (Looking Northwest)
Date of Photograph: 30 August 1982

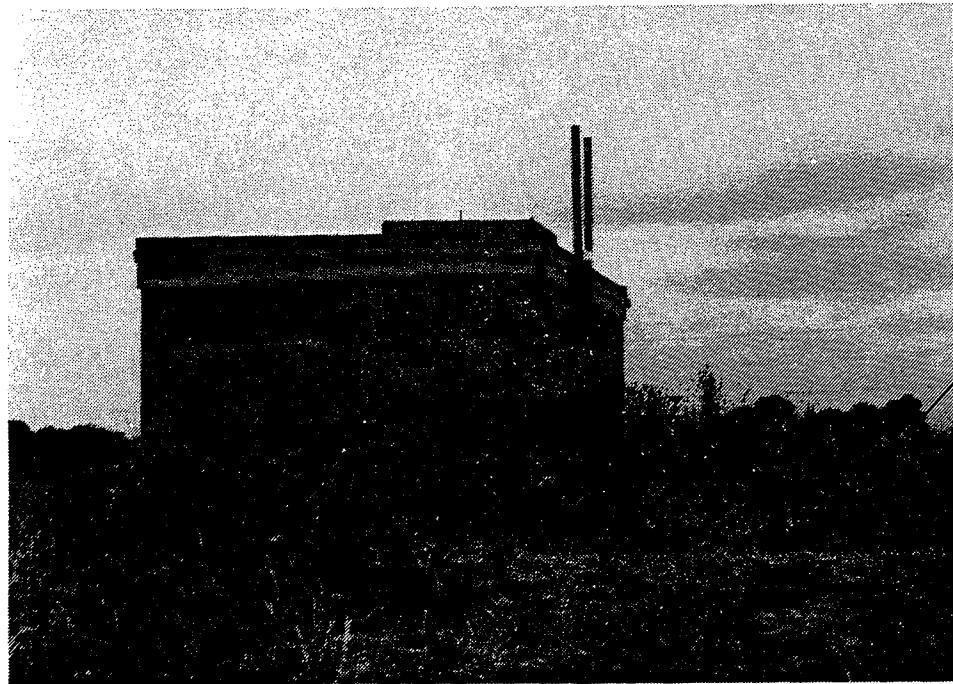
BUILDING NO. 386 (WELL NO. 2): General
View of Pump House. (Looking Southwest)
Date of Photograph: 30 August 1982

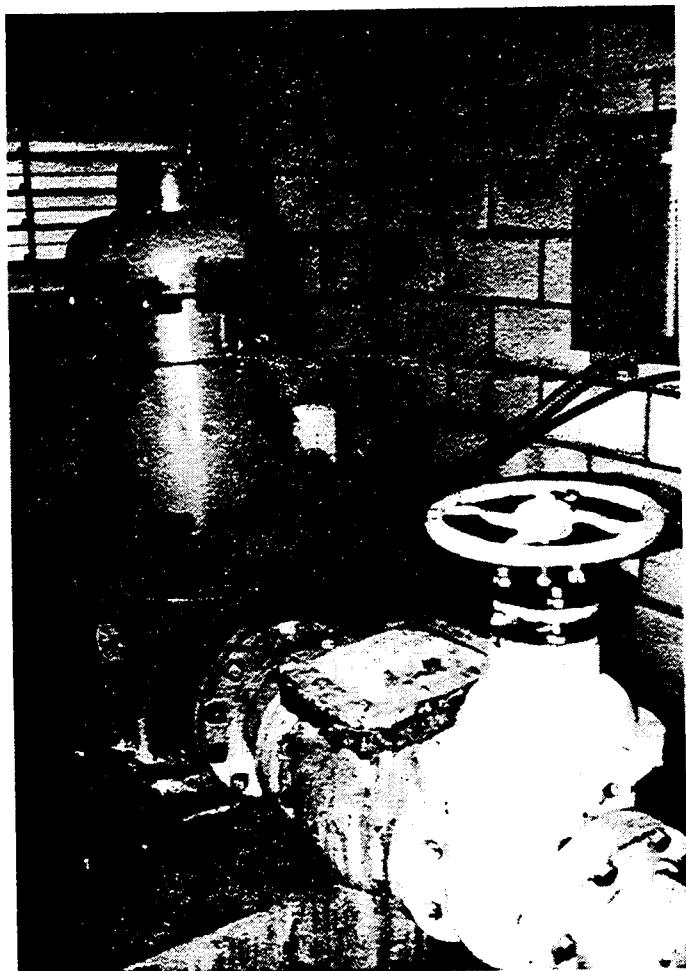
BUILDING NO. 387: Interior Controls
Date of Photograph: 30 August 1982

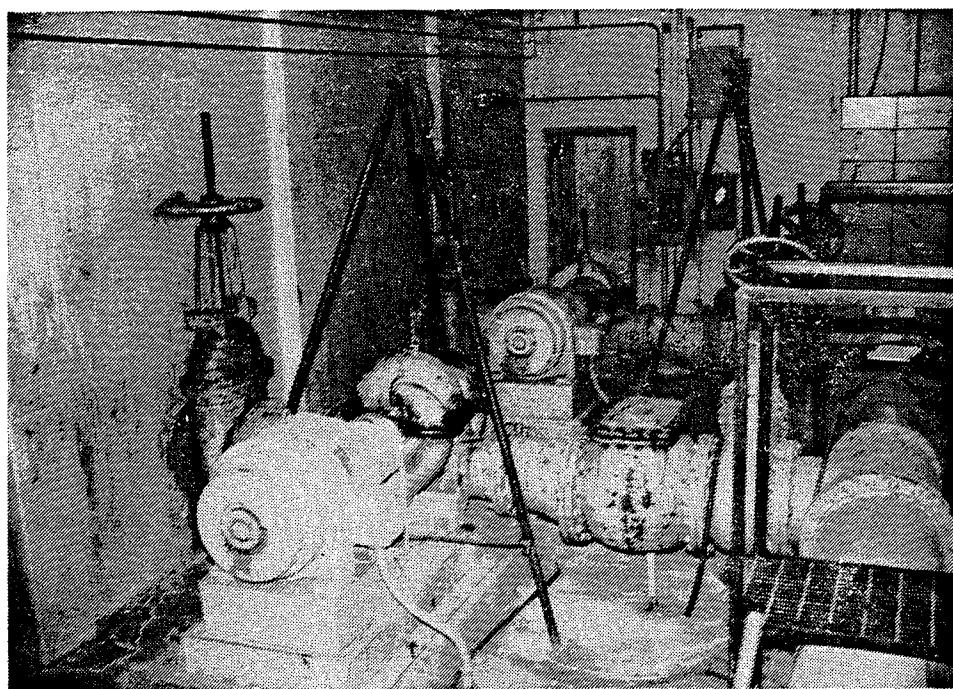
BUILDING NO. 548: Pump Room. General
View (Looking East)
Date of Photograph: 31 August 1982

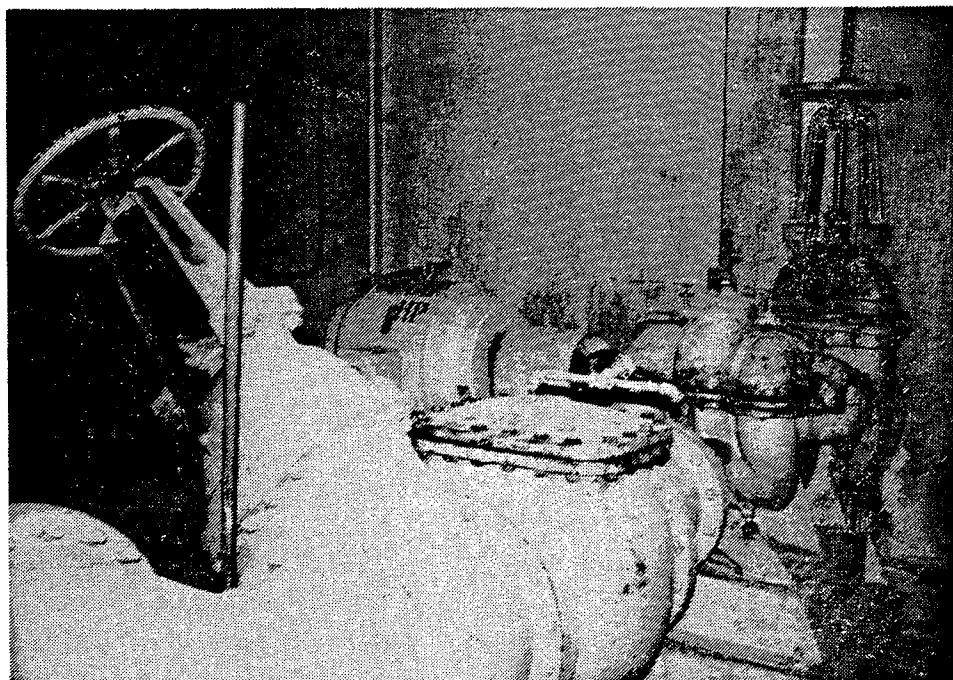
BUILDING NO. 548: Pump Room. General
View. (Looking West)
Date of Photograph: 31 August 1982

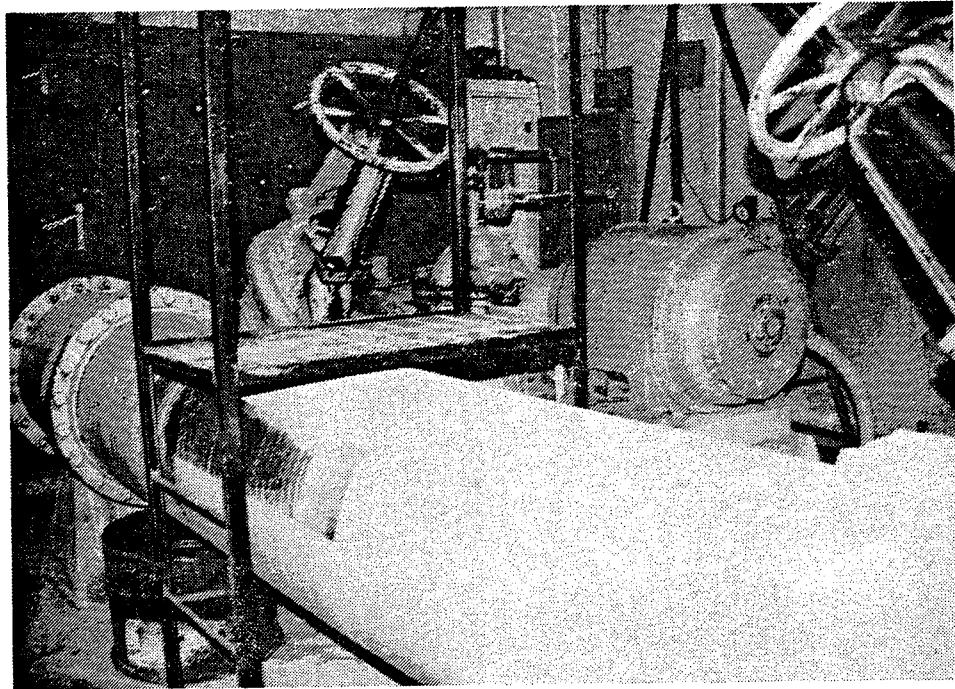
BUILDING NO. 548: Pump Room. Suction
Pumps and Header.
Date of Photograph: 31 August 1982

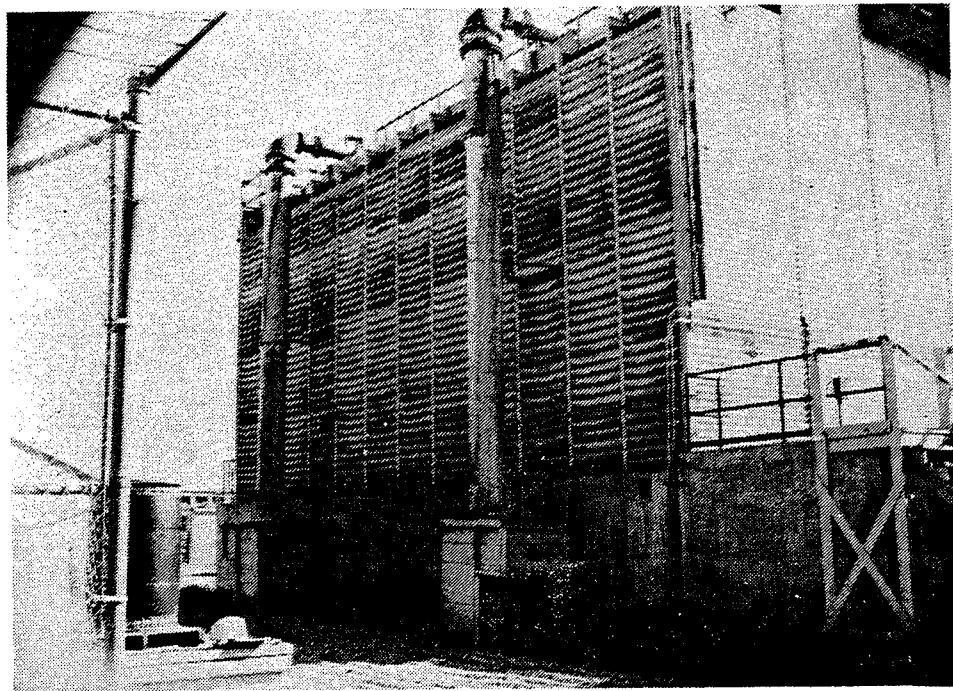
BUILDING NO. 549: Cooling Tower
(West Side)
Date of Photograph: 31 August 1982

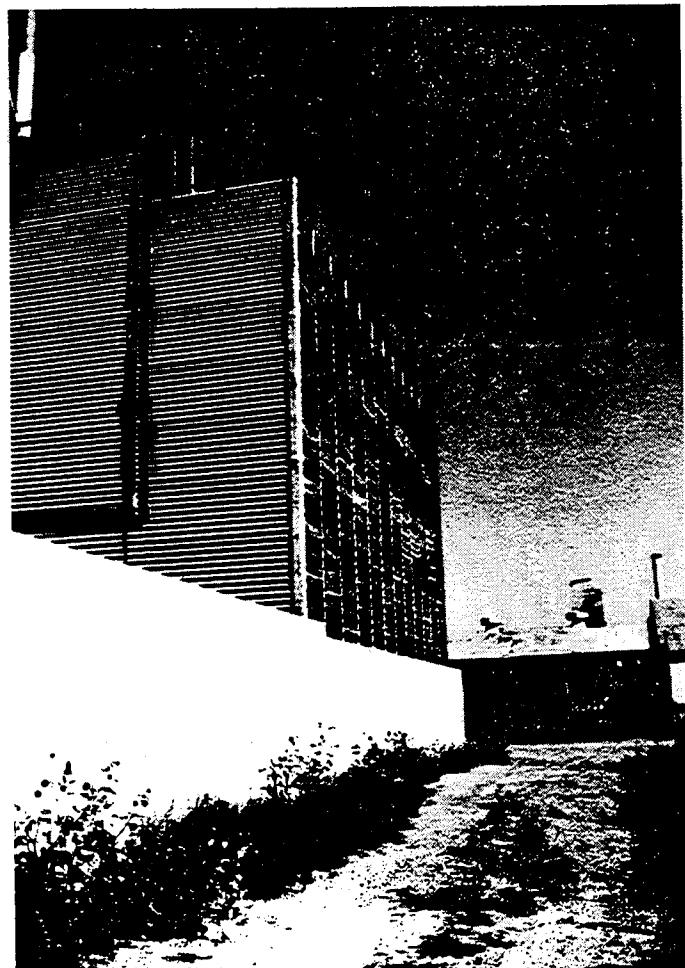
BUILDING NO. 549: Cooling Tower.
(East Side)
Date of Photograph: 31 August 1982

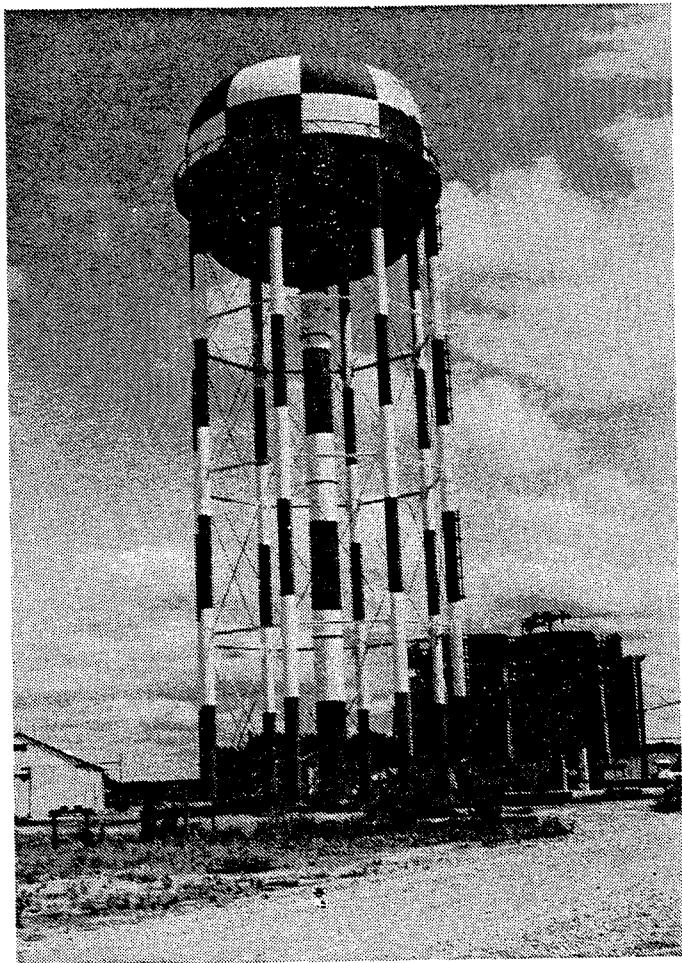
BUILDING NO. 551: Elevated Water
Tower
Date of Photograph: 31 August 1982

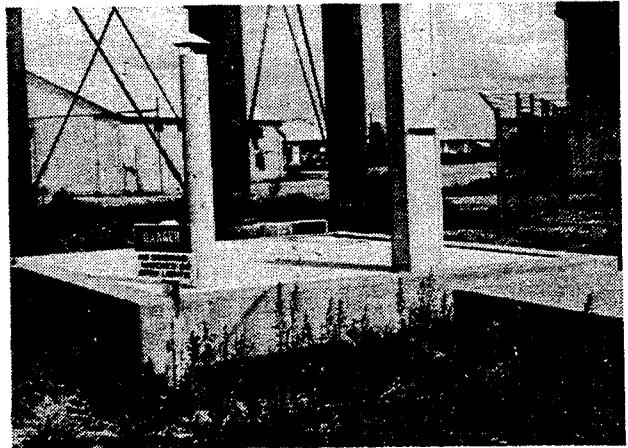
BUILDING NO. 551: Elevated Water
Storage (Looking West)
Date of Photograph: 10 September 1982

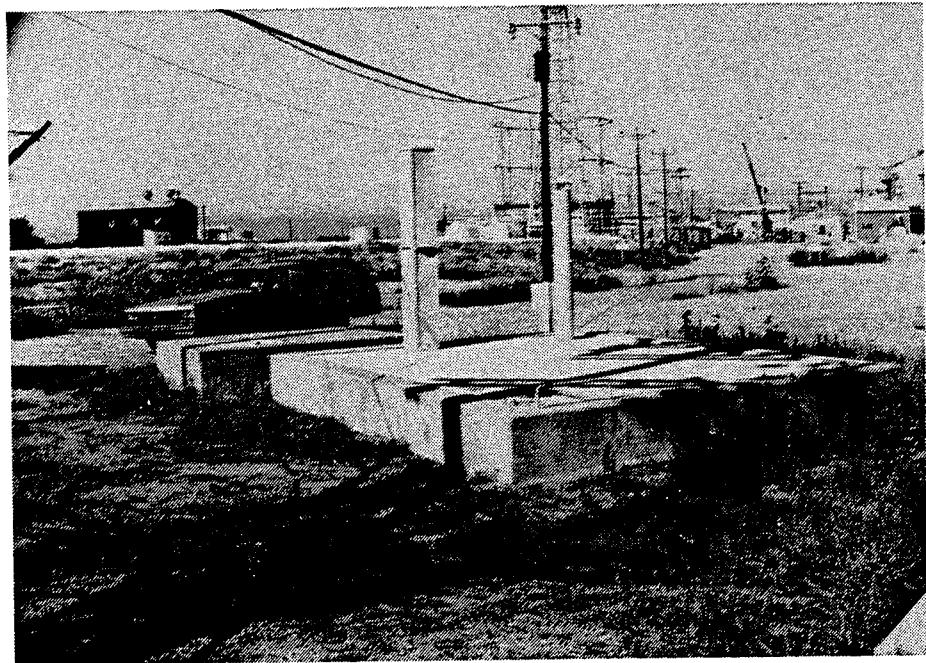
provided. The steam heating system for the elevated tank (#551) is also located in this pit. The only other utility is electricity. Condensation from the steam heating system has resulted in considerable corrosion on valves, pipe and ceiling. As a result the general condition of the structure is deteriorating.

BUILDING NO. 552: Valve Pit.
Exterior.

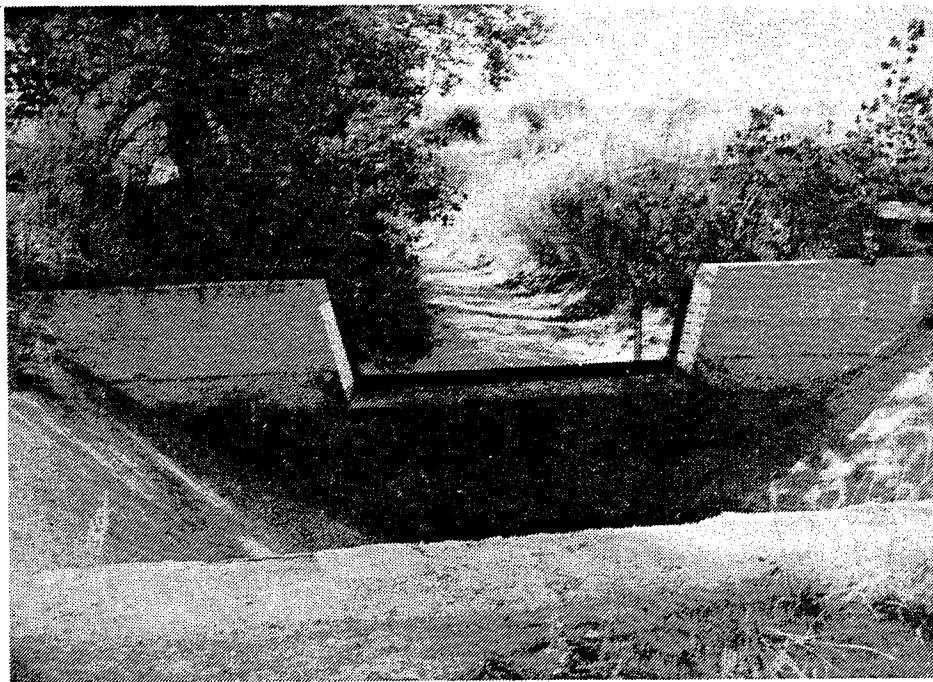
HIGHLINE CANAL: Diversion Control
Channel
Date of Photograph: 3 September 1982
